Signals in the Soil (CMMI-2034363)

Distributed Acoustic and Temperature Sensing in Permafrost Tundra in Utqiagvik, Alaska for Long-term, In-situ Permafrost Monitoring Using Ambient Noise

Xiaohang Ji

13th June 2023

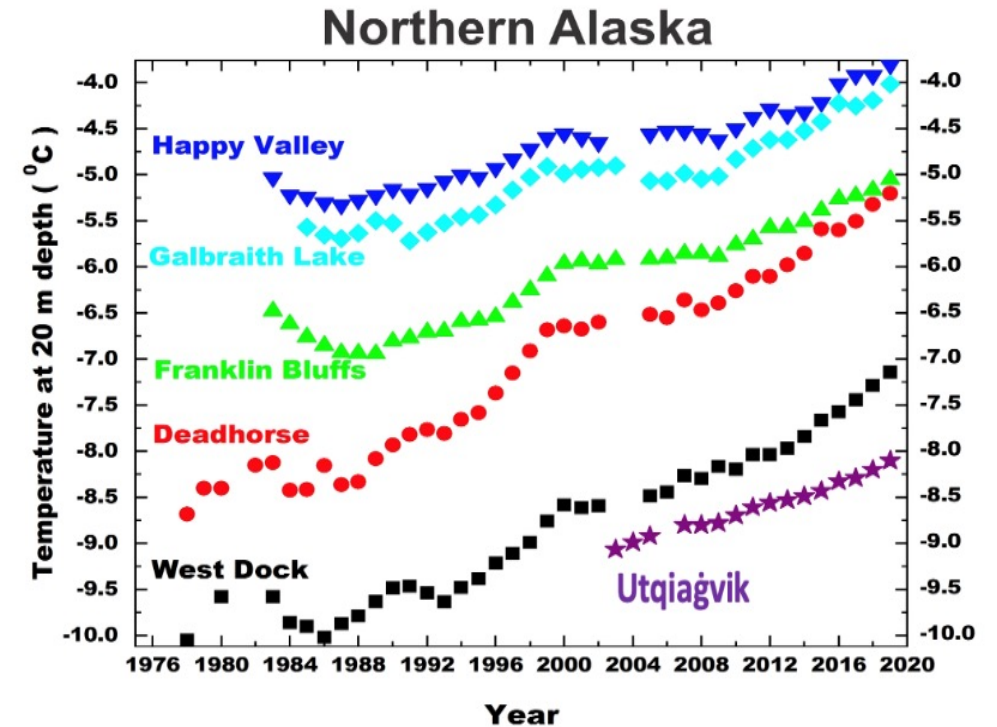
Permafrost temperature variations in northern Alaska (Romanovsky et al., 2019).

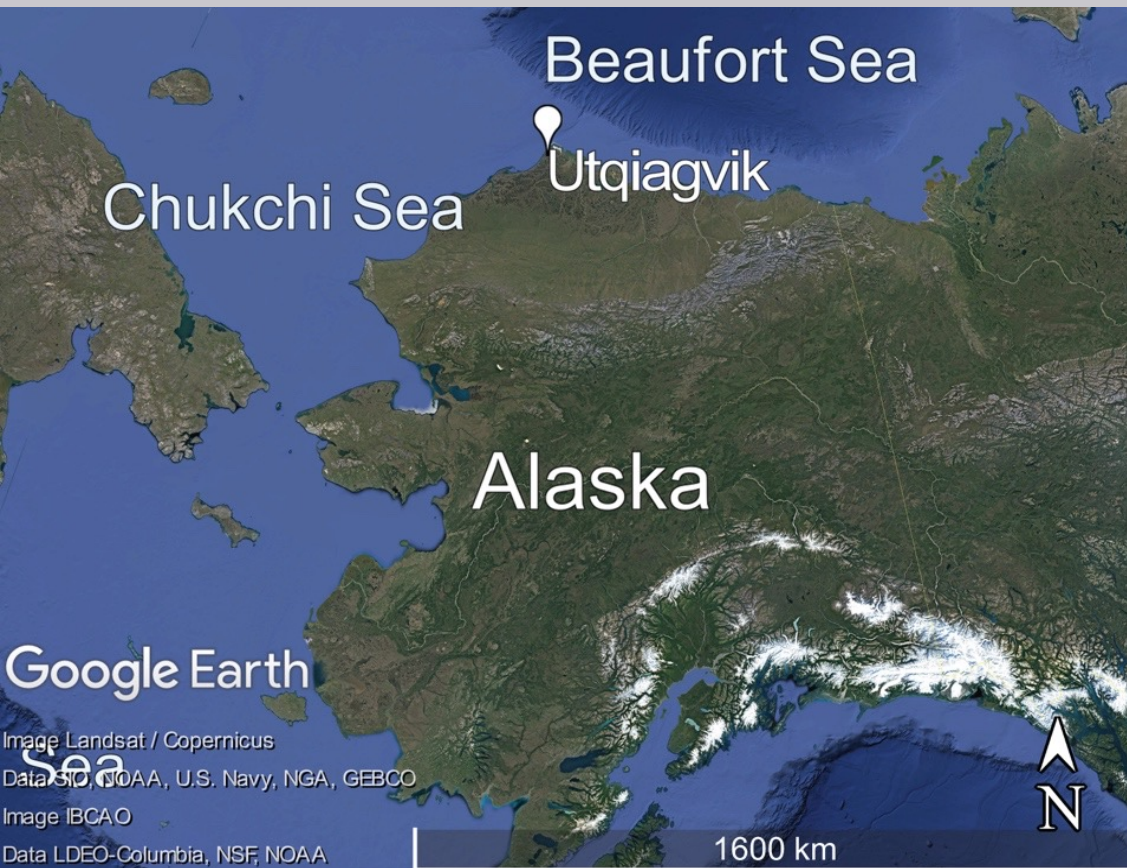
Total length: 2 km

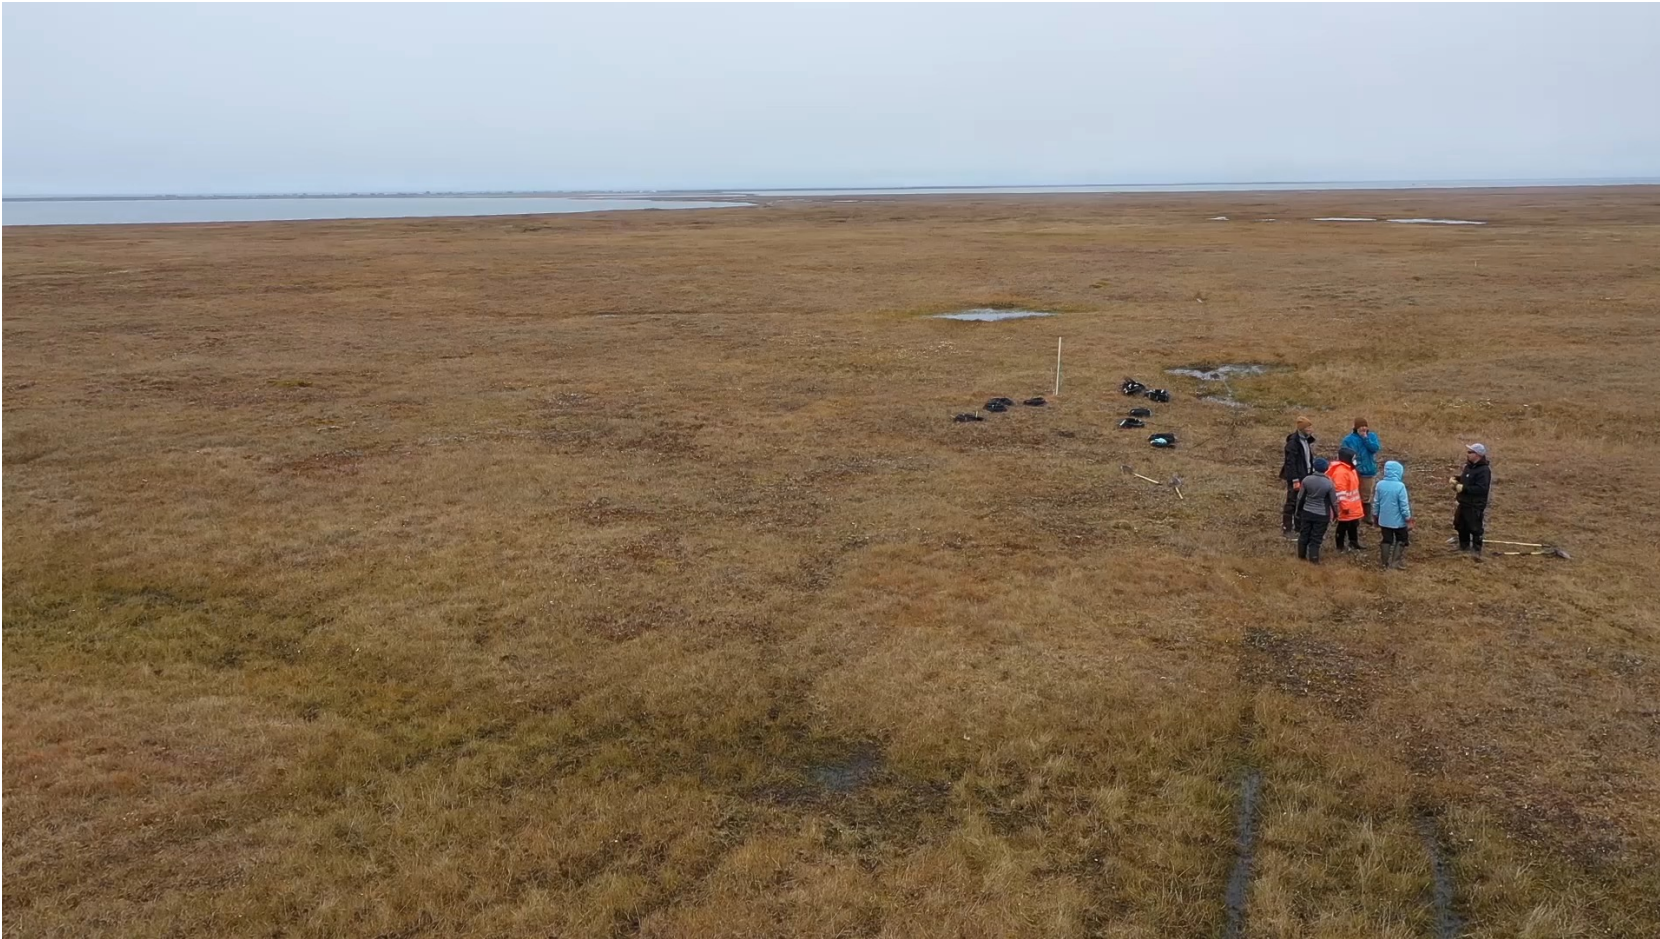
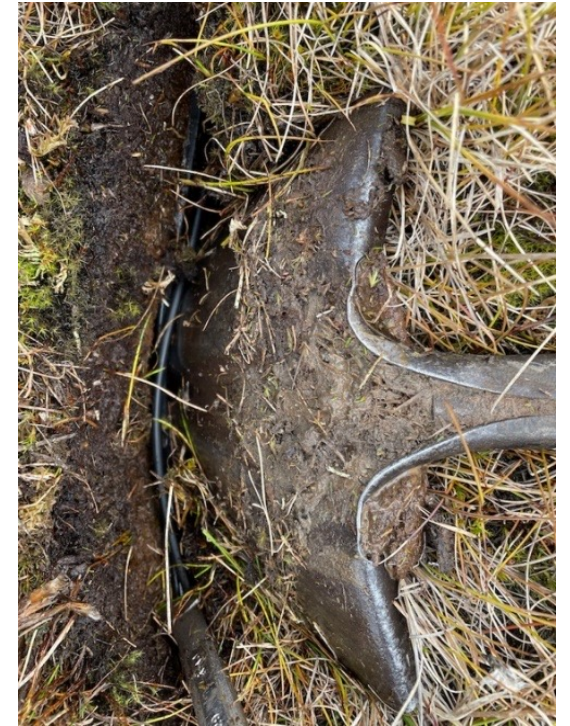
Cable embedment using shovel

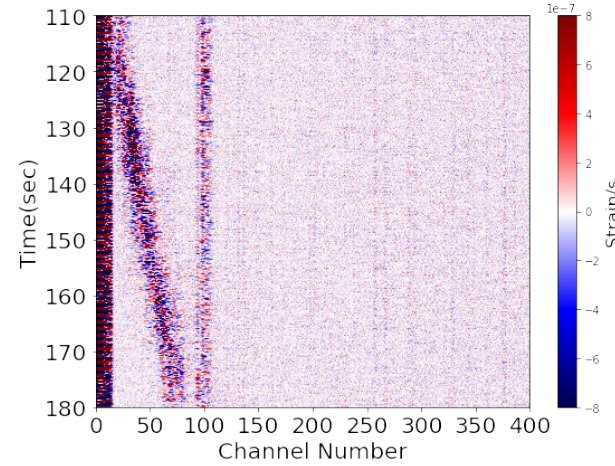
Short time window of straight segment of cable

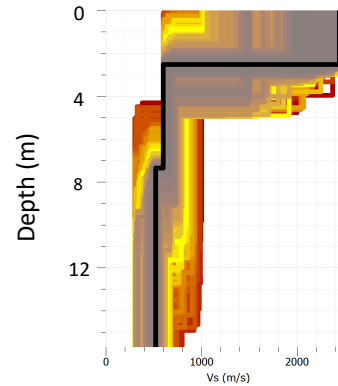
1D Shear wave velocity model created by the dispersion curve

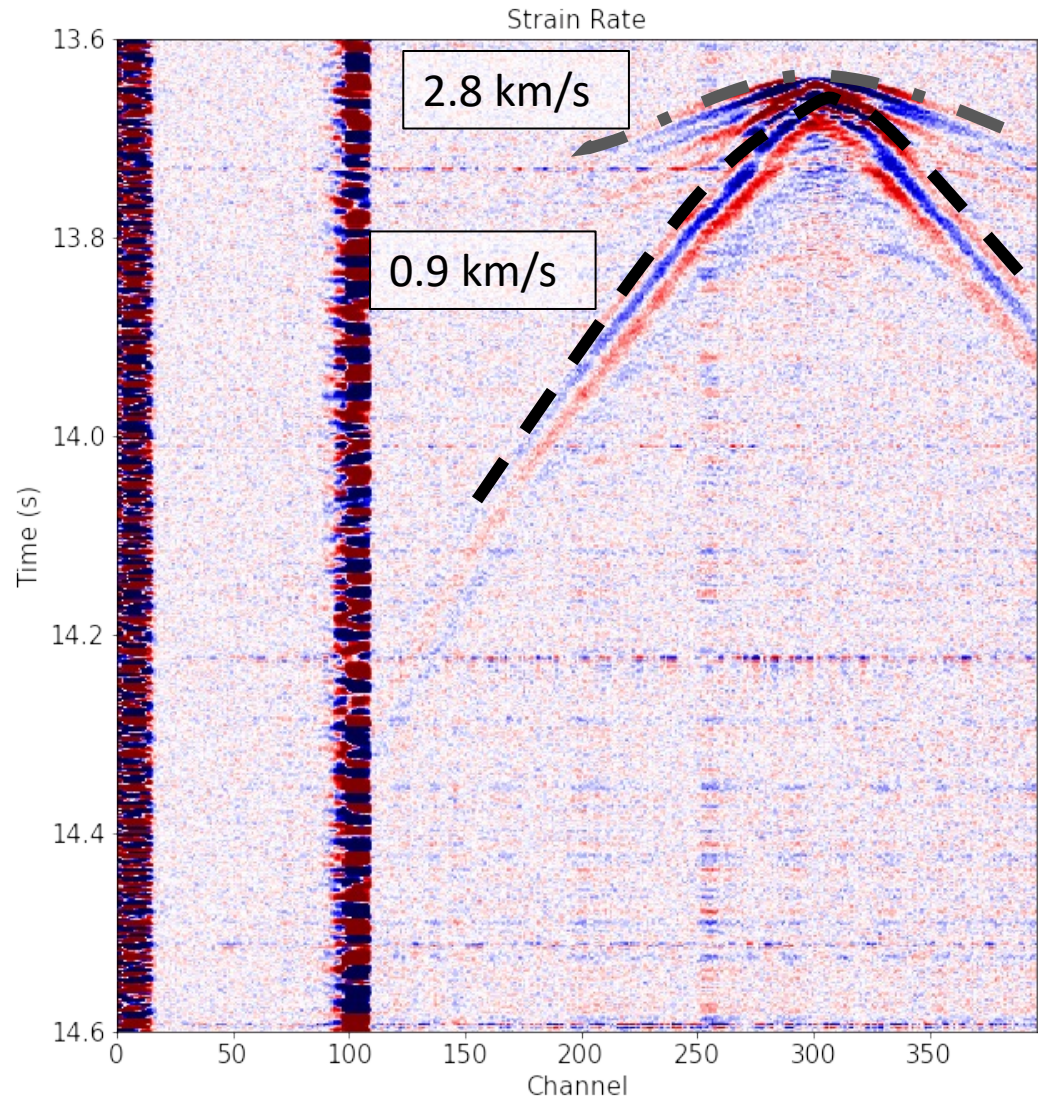
DAS Event Type: Ice Wedge/Ice Layer Cracking

Gauge Length: 20m ; Bandpass: 5 – 200Hz

Source Distance: ~ 70m

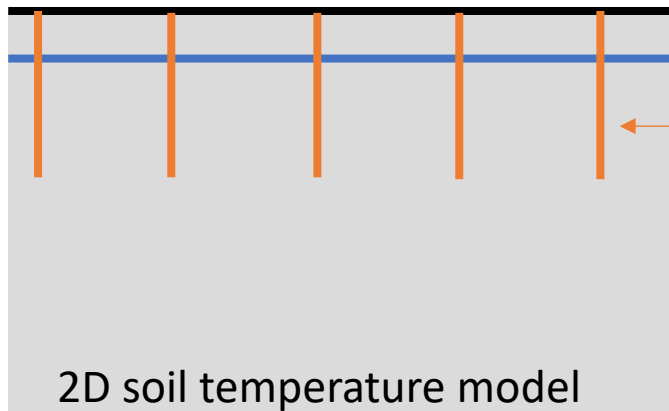
2D soil temperature model

GIPL model (Geophysical Institute Permafrost Laboratory)

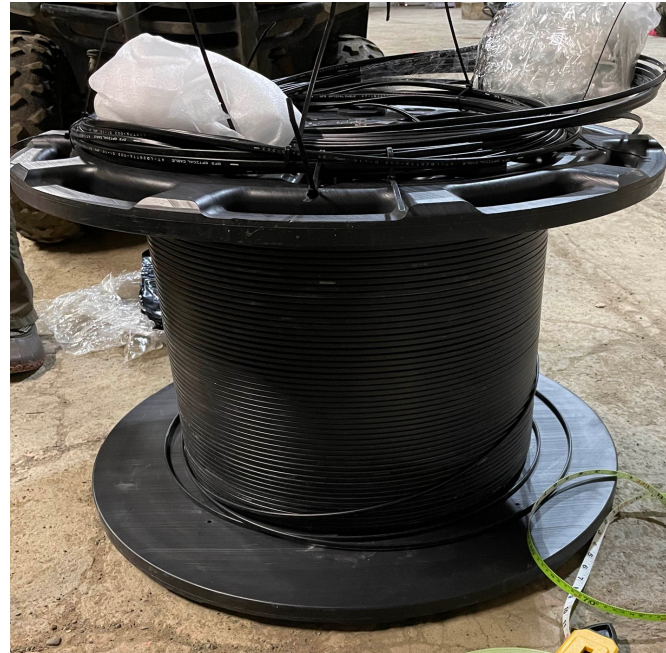
DTS cable

Depth: at 0.2 – 0.3 m

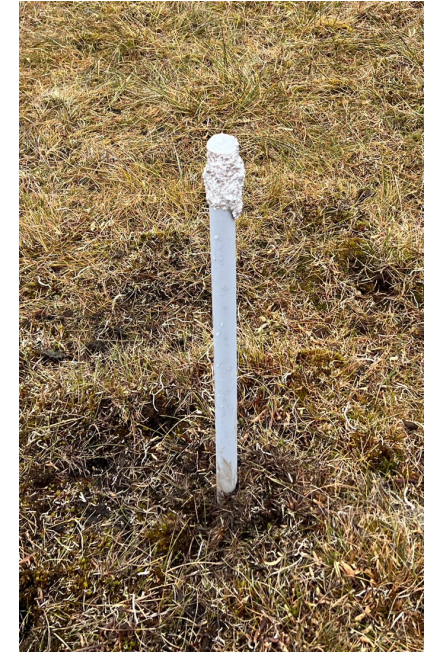
Thermometer installation

Depth: up to ~1.5 m

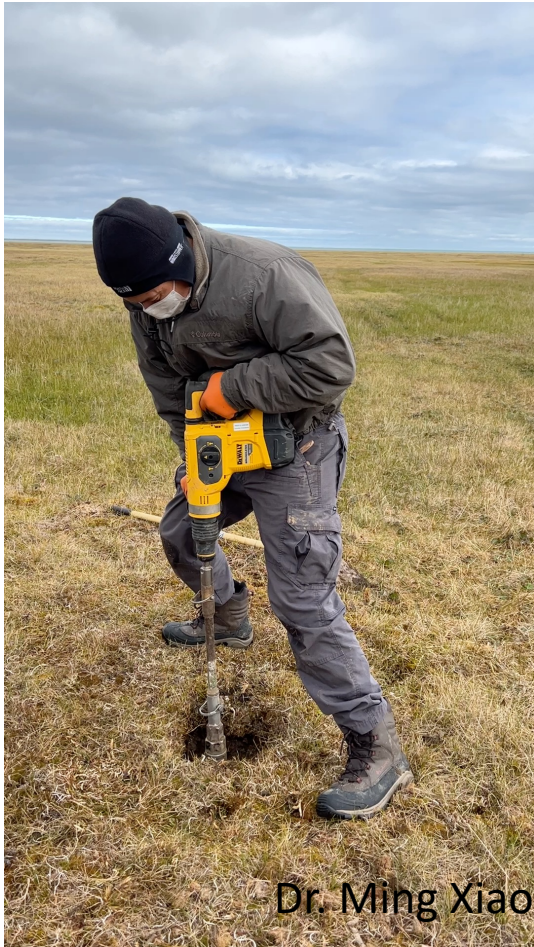
Hand-held driller and boring log

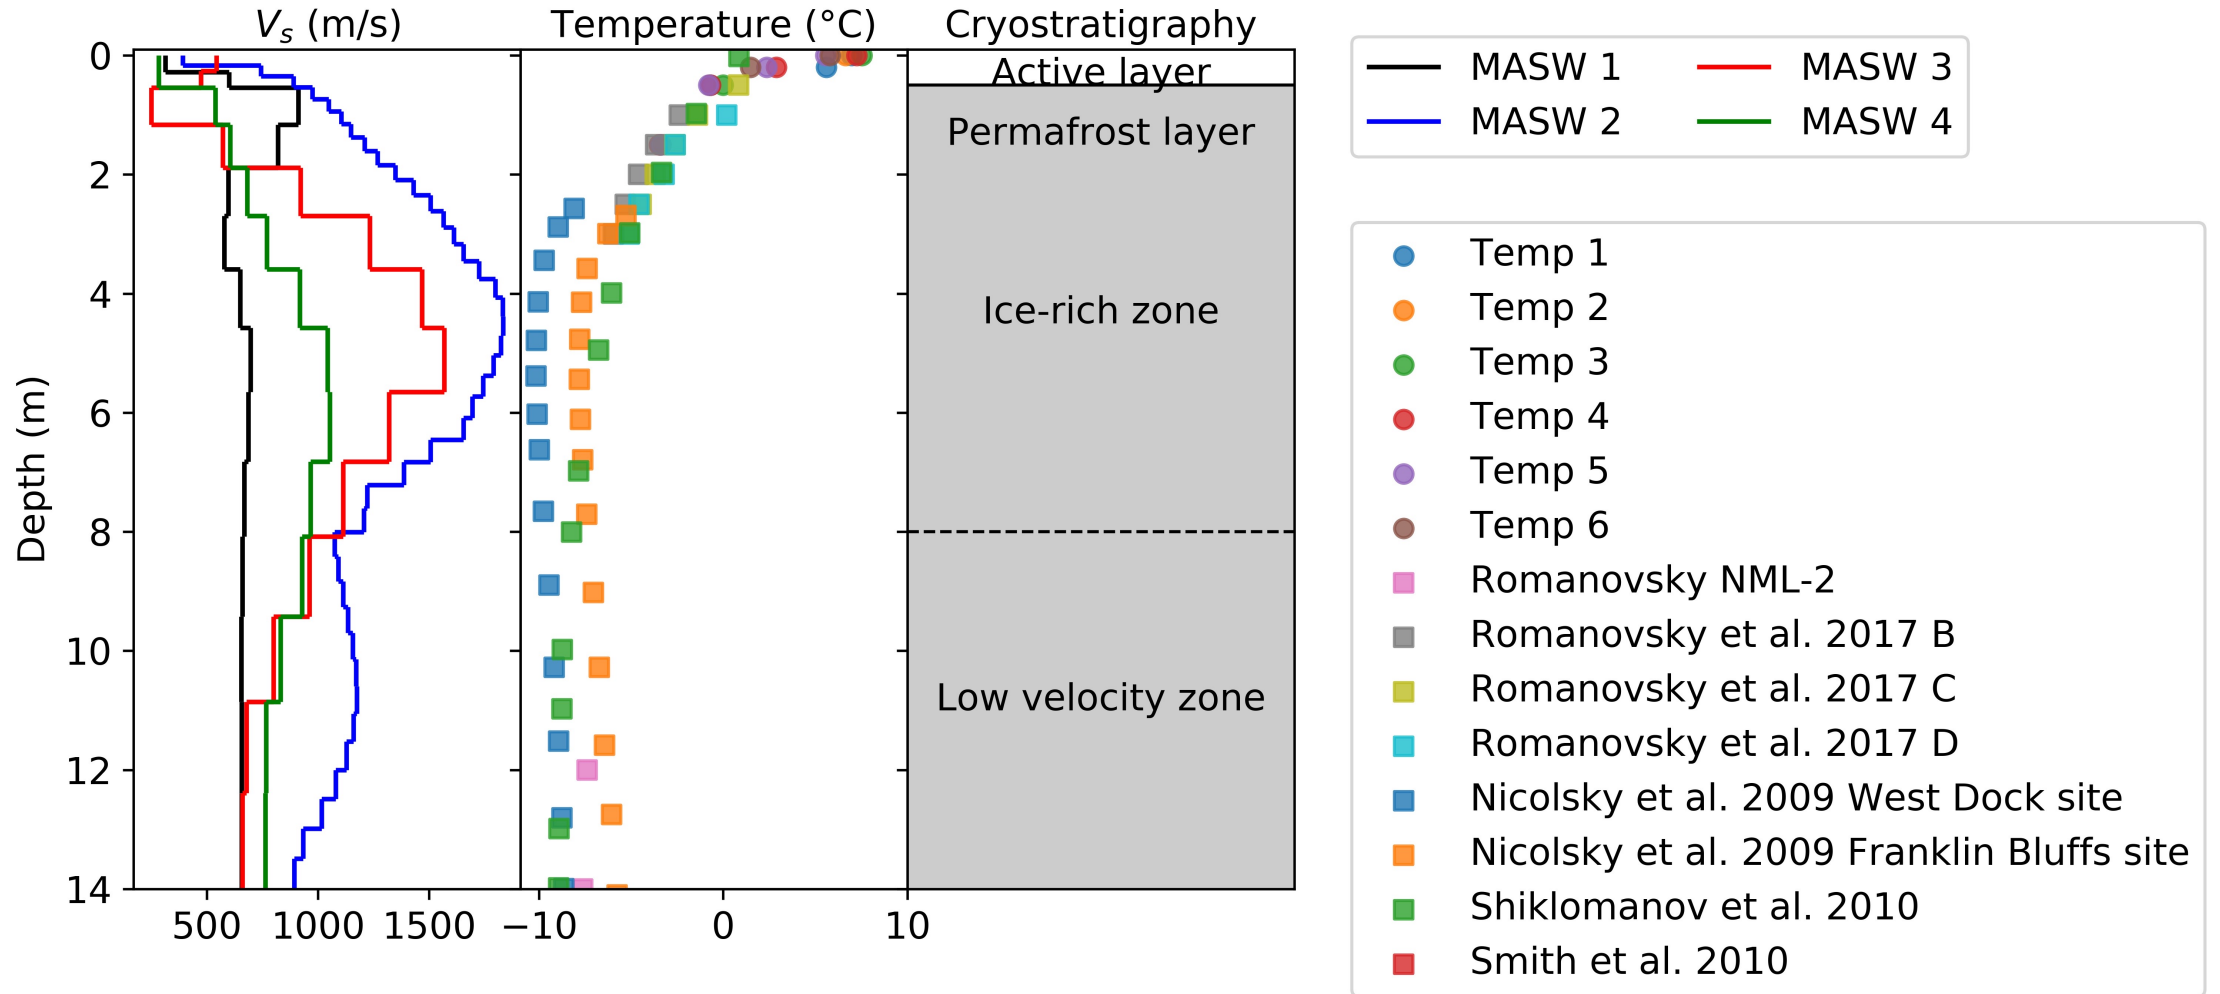
1D Vs Profiles and Temperature
